Helicopter Long Line Strikes High Tension Guide Wire

CAGC SAFETY ALERT

Safety Alert

03-07

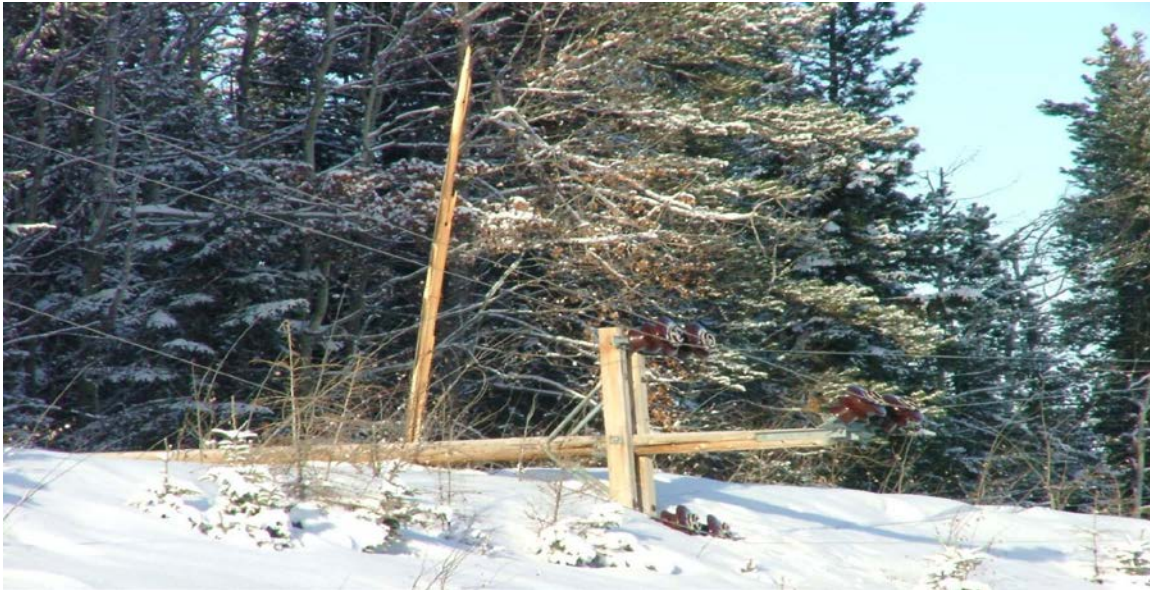
- The power line enters the Hwy right-of-way from the cut line constructed for the power line right-of-way;
- The receiver line (R171) crosses Hwy 47 just before the power line enters the Hwy right-of-way;
- The unmarked high tension guide wire supporting the transition of the power line crosses the Hwy.

- Hazard for the aircraft and aircrew should be identified on a hazard map and should be included in safety meetings. In addition, personnel working on the ground should assist the pilot by visually identifying hazards and marking them accordingly;
- Pilots to participate in work site hazard analyzes and communication;
- When aircrew change out for regular rotation, departing aircrew to brief arriving aircrew on project procedures and review any change(s) in work site hazard analysis, this is to be documented;
- Orientations for aircrew new to site are mandatory. Arriving aircrew must check into crew office before entering job site for briefing and / or job site orientation;
- Helicopter flight paths must be arranged so as to reduce the potential for low altitude encounters with overhead lines.
