Towing Incident

CAGC SAFETY ALERT

01-09

January 17, 2009

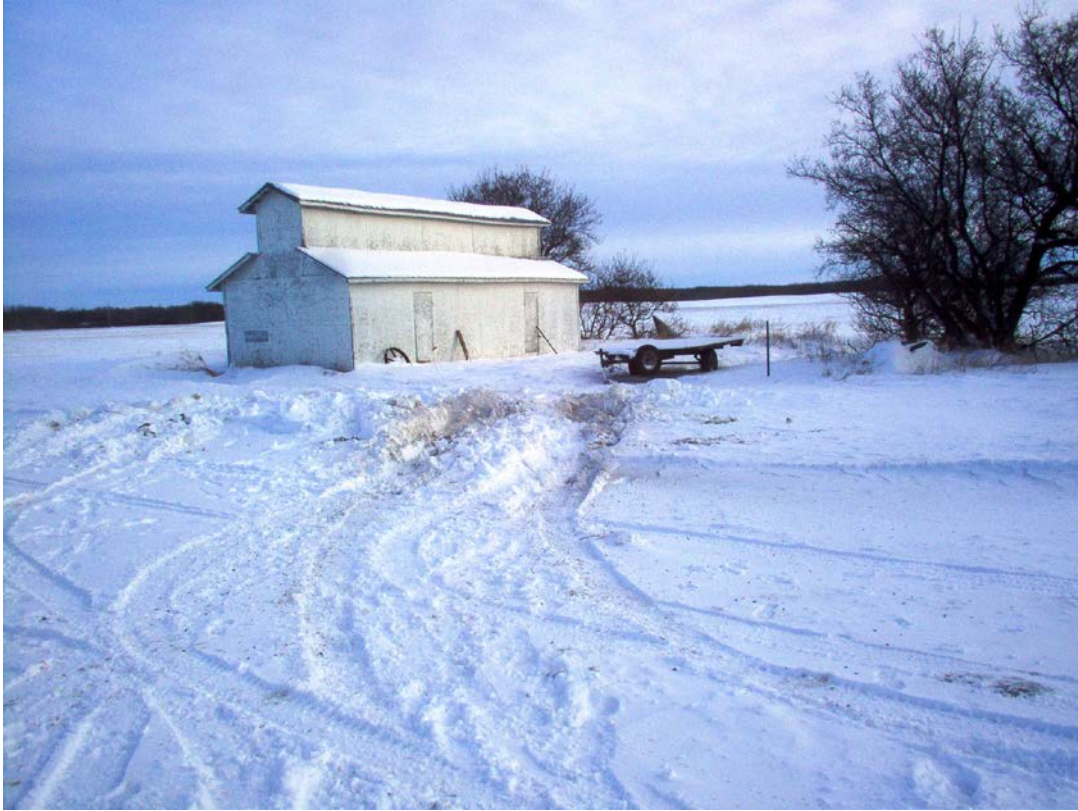
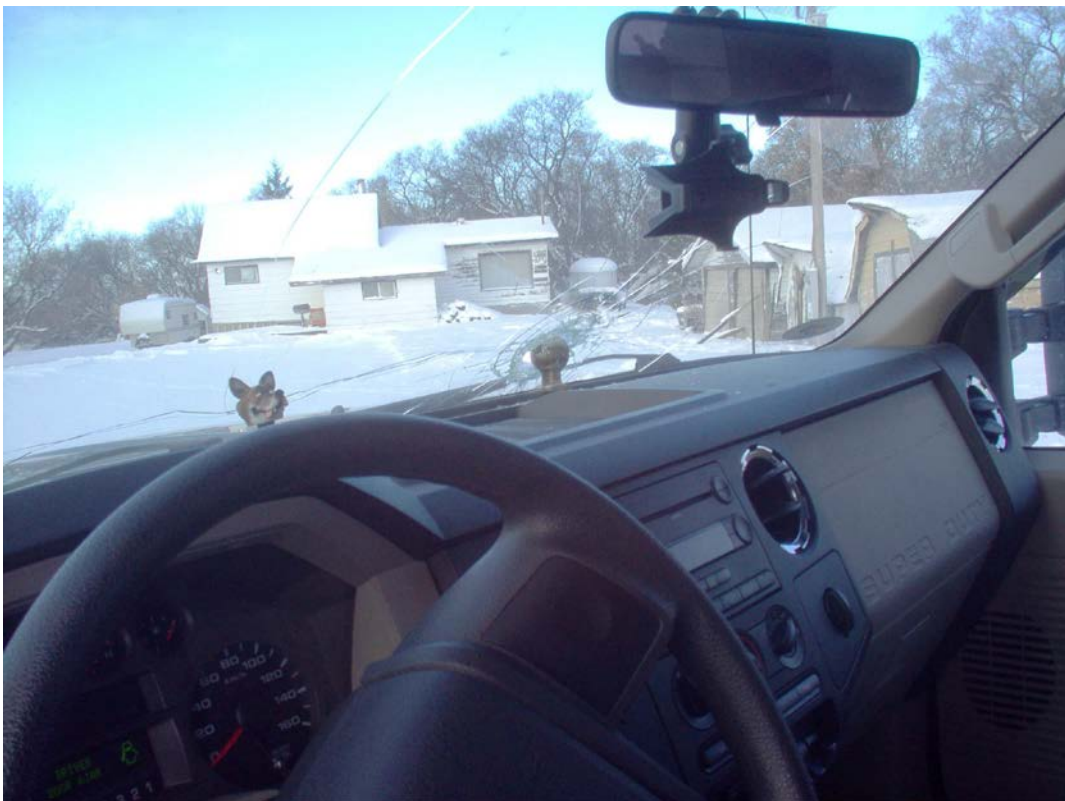
This incident occurred in an abandon farmyard; the party involved indicated they were pulling-out a fellow employee's truck from a snow bank. During the process of attempting to dislodge the stuck vehicle the "ball hitch" pin broke, projecting the ball through the back window of the vehicle doing the towing (past the headache rack) and striking the front window on the passenger side.

The vehicle is still road-worthy and arrangements for new windows have been made.

It has been recommended that crew members have clavicies on hand
