Mechanical Release Failure - Helicopter

CAGC SAFETY ALERT

Safety Alert

07-11

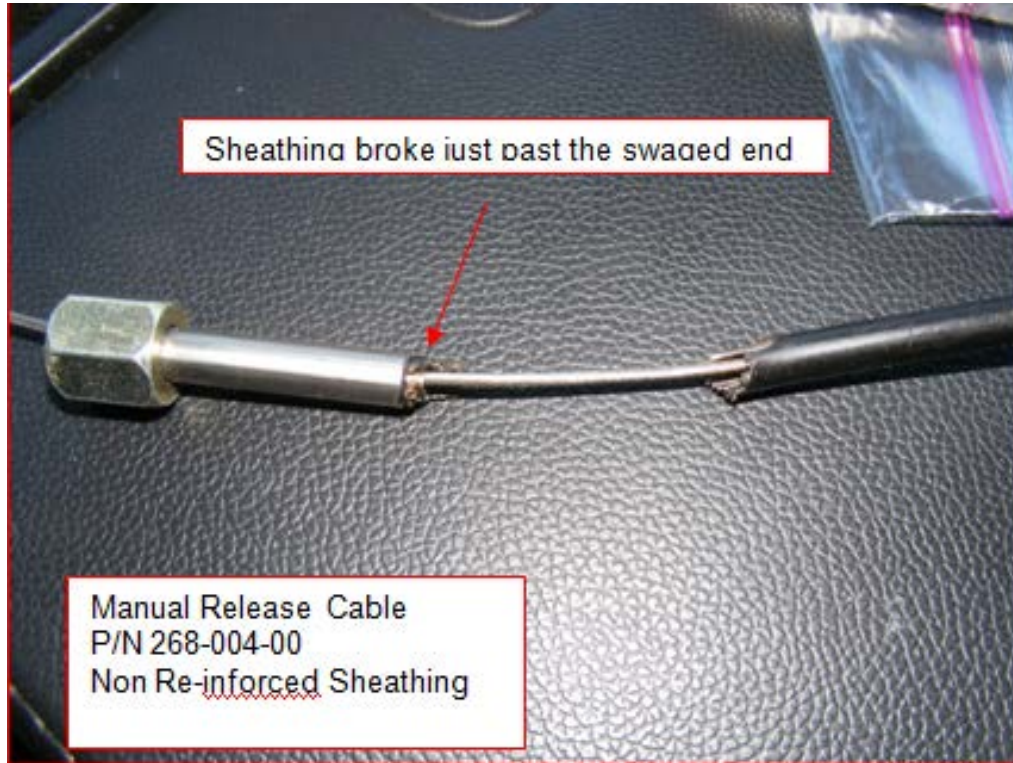
After landing and shutting down, the Engineer and Pilot inspected the hook. Upon investigation and testing it was discovered that the mechanical release cable sheath had broken just before the insertion head at the hook causing the sheath to slip, thereby allowing the release to be engaged.

The break in the cable sheath occurred at a point of stress caused by the movement of the hook as it travelled laterally along the load beam. The hook released its load when the manual release cable sheathing broke just behind the swaged head at the hook end of the cable. The sheathing break allowed for motion in the cable that engaged the release mechanism on the hook. Due to the light load on the hook the Pilot did not feel the release happen in cruise.

Broken sheath with black tape removed

- Change of aviation industry best practice: discontinue the practice of covering mechanical release cables with black electrical tape. If tape is discovered during the daily inspection, tape should be removed to allow complete visual inspection of covered area;

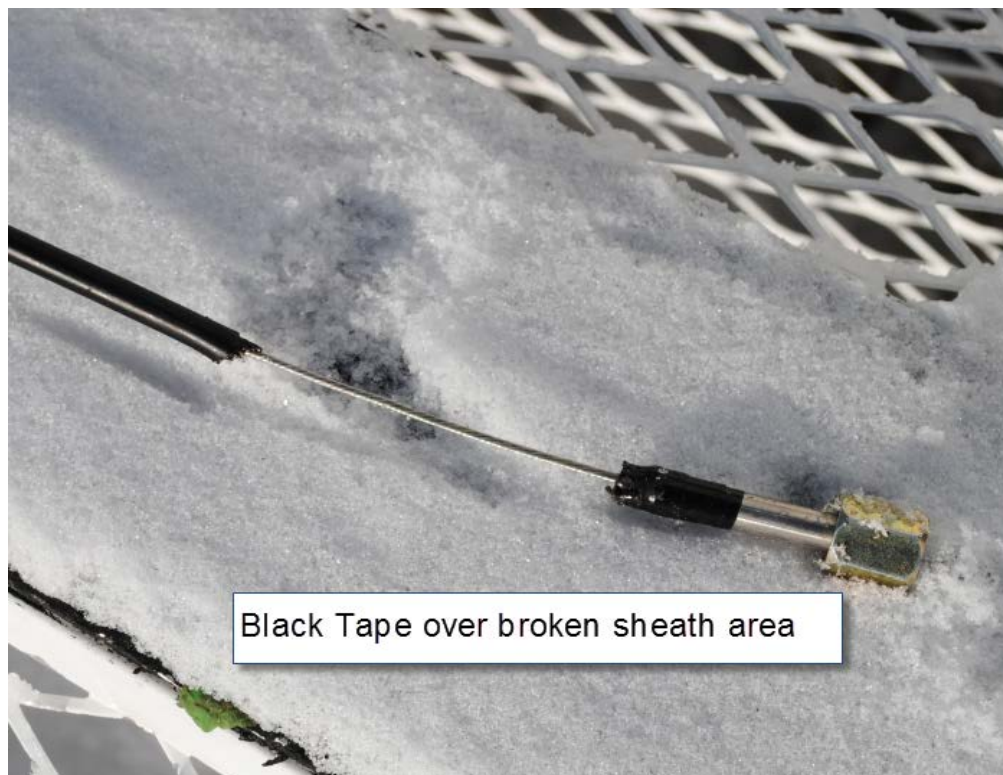
Several months prior to the incident, sheath damage to the cable in question was identified by the Engineer on site and at the time was deemed not to compromise the integrity of the hook; operations continued and the area showing minor damage was covered by black electrical tape – a common aviation industry practice. The Engineer also proactively ordered a replacement part in case, the cable condition deteriorated to the point it needed replacement. The replacement part had been received prior to the incident and was available at site for installation.

Broken sheath with black tape on

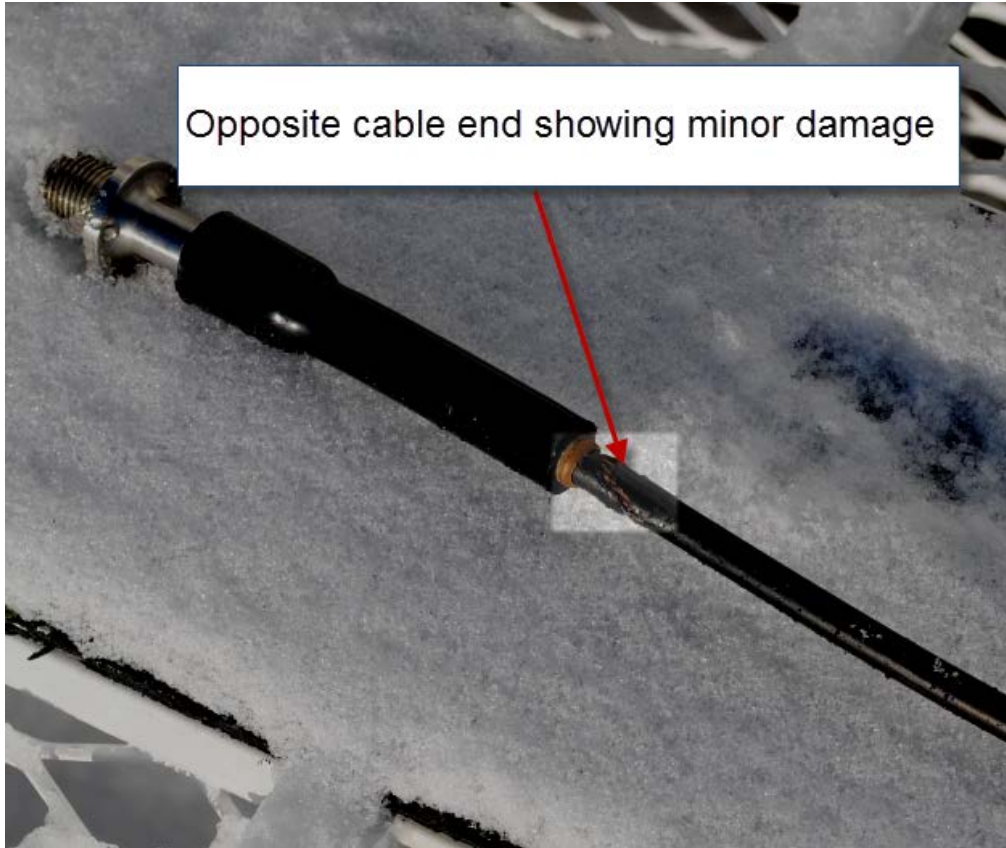
Opposite end of cable showed some minor damage. It is an industry norm to use electrical tape to cover over areas such as these.

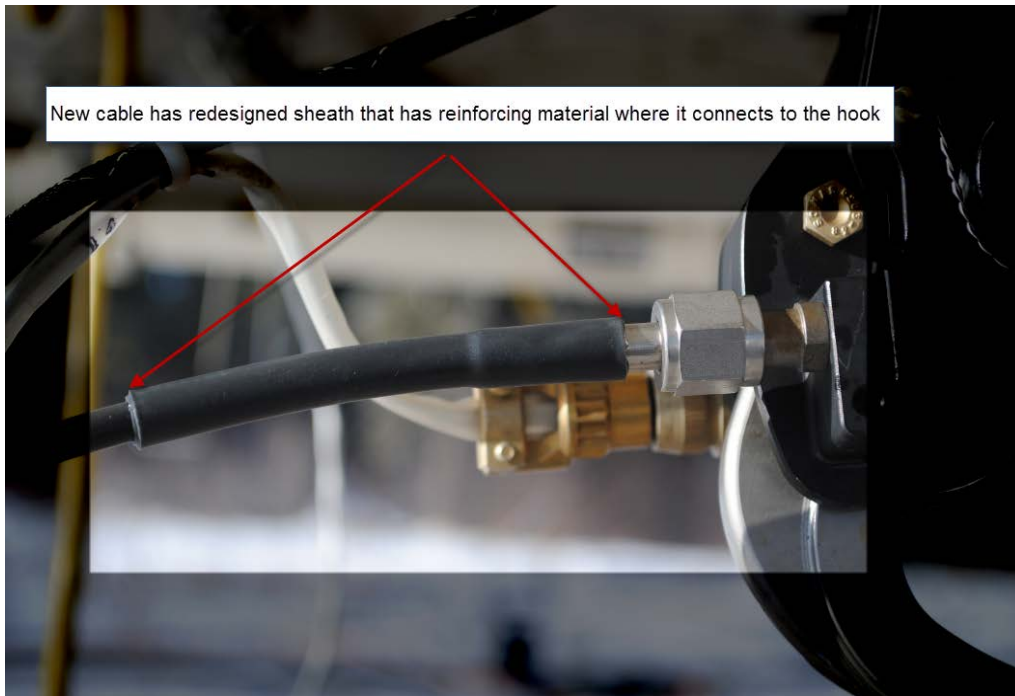
Photo shows insertion point of cable to hook and the new style replacement cable with the additional reinforcement of the area in question.

- Immediate release of companies Maintenance Directive requiring additional mandatory hook inspection criteria for Engineers;
- Immediate fleet wide replacement of mechanical release cable 260-004-00;

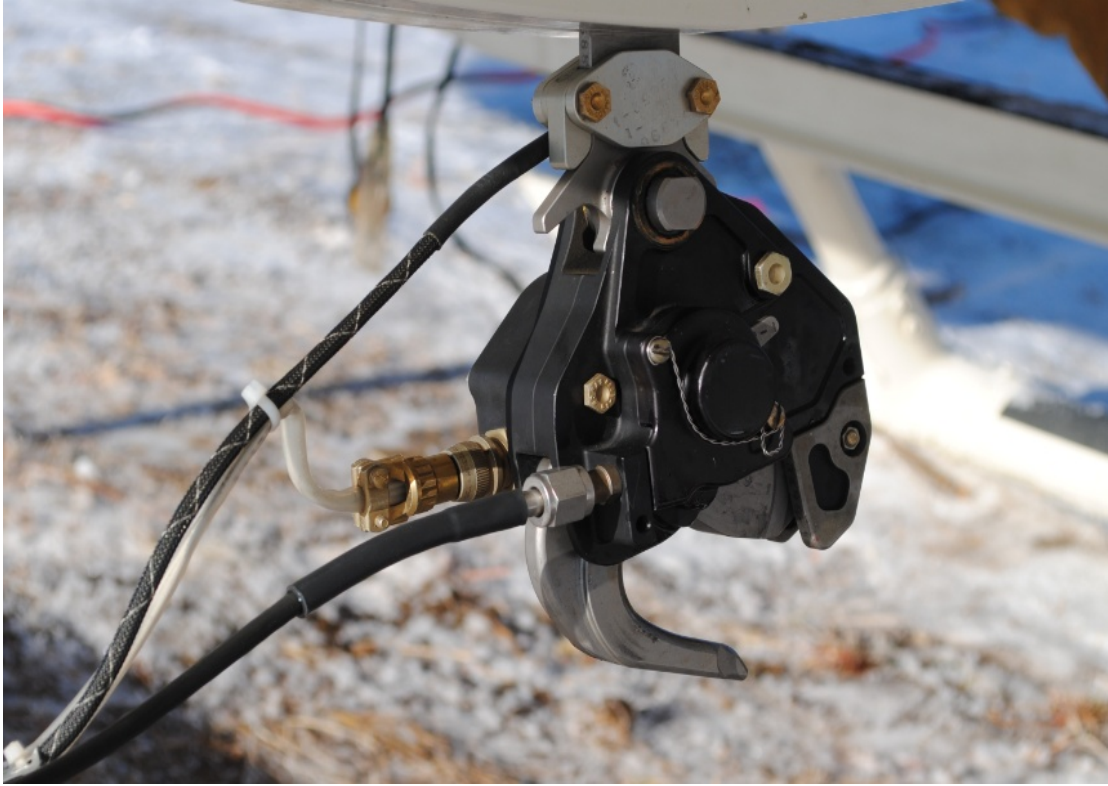
Photo showing normal hook configuration - new cable part installed
