# EXCAVATION EQUIPMENT DAMAGE

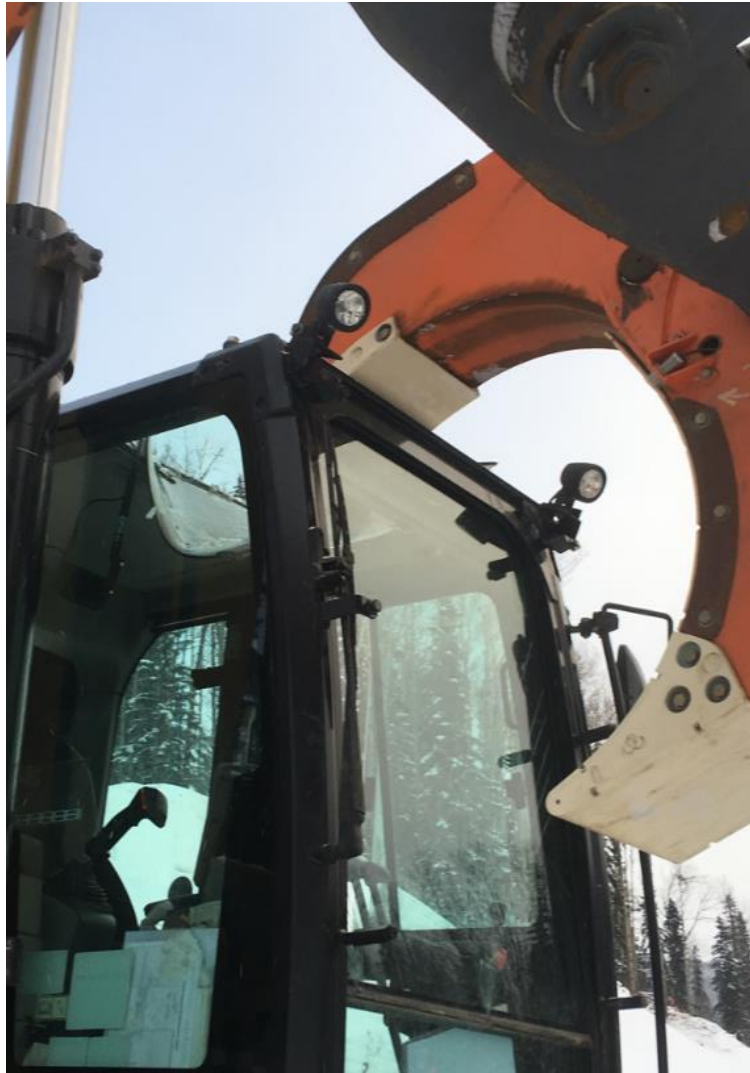
A mobile mechanic was required to get the excavator running, and it took 1.5 hours to start the equipment due to the extreme cold. The operator had let the excavator run for approximately 20 to 30 minutes, and then began the pre-use inspection and functionality test. As the boom was lifted during part of the functionality test, the pipe arm attachment started curling inward on its own towards the cab of the excavator. It impacted the top of the excavator cab damaging the skylight, skylight latch and cracking the front windshield.

**The pipe arm impacted the cab**

Hydraulic fluid in the excavator had thickened due to the drop in temperature, freezing the components in the oil, which impacted the response of the pipe arm attachment.

There was not enough warm-up time to allow for adequate fluid circulation in the extremely cold weather conditions, and the operator did not engage the secondary engine shut-off switch.

- When ambient temperatures fall below -18 C, an extended warm-up/fluid circulation time should be implemented to compensate for potentially thickened fluids
- The company has implemented an emergency engine shut down procedure
- The manufacturer suggested that a pipe arm attachment should not be used in temperatures below -30 C
- Check with manufacturer for appropriate fluids and temperature ratings
