WORKER STRUCK BY PIPE WRENCH

DESCRIPTION:

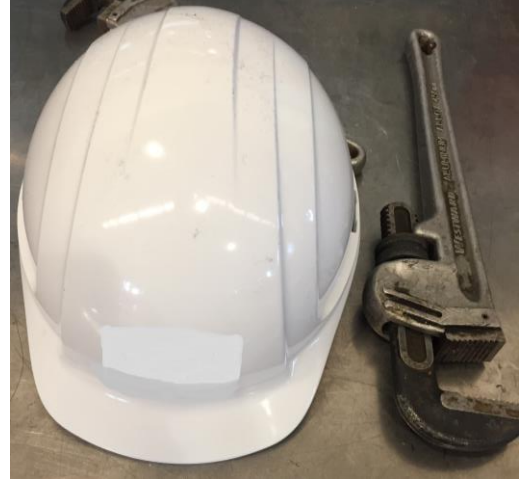
The fisherman was on the rig floor while waiting for the service rig crew to complete their tasks. A service rig crew member removed the last drill collar and installed a lift sub using a pipe wrench. A worker installed the sub and fisherman then operated the power tongs to allow the tightening of the lift sub's remaining threads. At the same time, another crew member released winch controls, which redirected all hydraulic power to the power tongs and revved the engine. The extra engine capacity in the power tongs spun the equipment and attached pipe wrench into the fisherman. The impact threw the fisherman several feet, he was immediately transported to the hospital.

A pipe wrench was left on the lift sub while power tongs were being operated, and the re-direction of all hydraulic power to power tongs when the engine revved.

- Unable to disable hydraulic power to power tongs due to rig design
- Fisherman operated the equipment while not formally authorized
- Incomplete risk assessment highlighting potential hazards and outcomes

- Communicate any equipment energy hazards (potential hydraulic power issues) to workers on site
- Formal turnover and authority procedures should be in place and used
- Ensure no third party workers are in the area until control of authority has been transferred
- Companies could inventory all their equipment where the hydraulic power hazards remain and determine whether or not feasible to retrofit
