**SAFETY ALERT - #52-2005**  
**ABANDONED DRILLING LEASE – OPEN HOLE**  
**RELEASE DATE: SEPTEMBER 6, 2005**

<b>Function:</b> Exploration	<b>Incident Date:</b> August 19, 2005
<b>Location:</b> Onshore	<b>Location Detail:</b> Wellsite
<b>Incident Type:</b> Near miss	<b>Country and Region:</b> Canada, NW Alberta

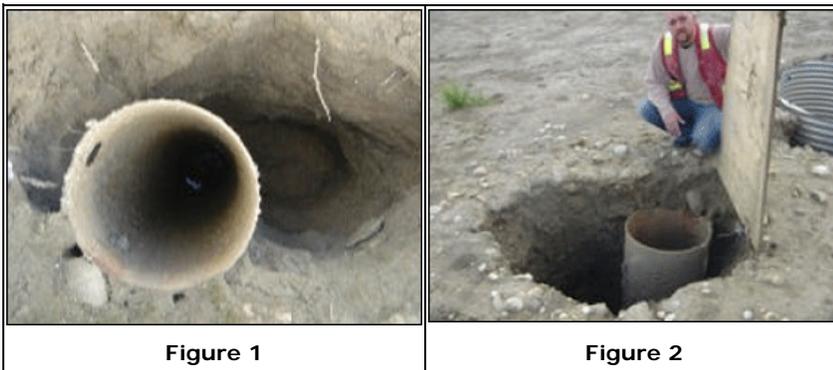
**Photos:**

Upon further investigation, it was determined that there was an open excavation around the abandoned hole, and it had filled with mud and water. It was also discovered that there were several other abandoned leases in the area with open holes (see Figure 1 and 2). It is believed that these are drilling "ratholes." During drilling operations, the kelly is placed in the rathole when hoisting operations are in progress.

1. Consult with the Canadian Association of Geophysical Contractors (CAGC) to obtain help with this issue as there does not appear to be any specific regulation regarding how drilling companies and lease owners are required to safely abandon ratholes on a lease site.
2. All field managers should discuss this incident with field employees and contractors to ensure that all operations phases are aware of the potential for this kind of incident.
3. Any worksite with existing wellsites will require a specific hazard assessment to determine the potential for this type of condition.
