SAFETY ALERT

January 13th, 2015 – High Speed Vehicle Collision

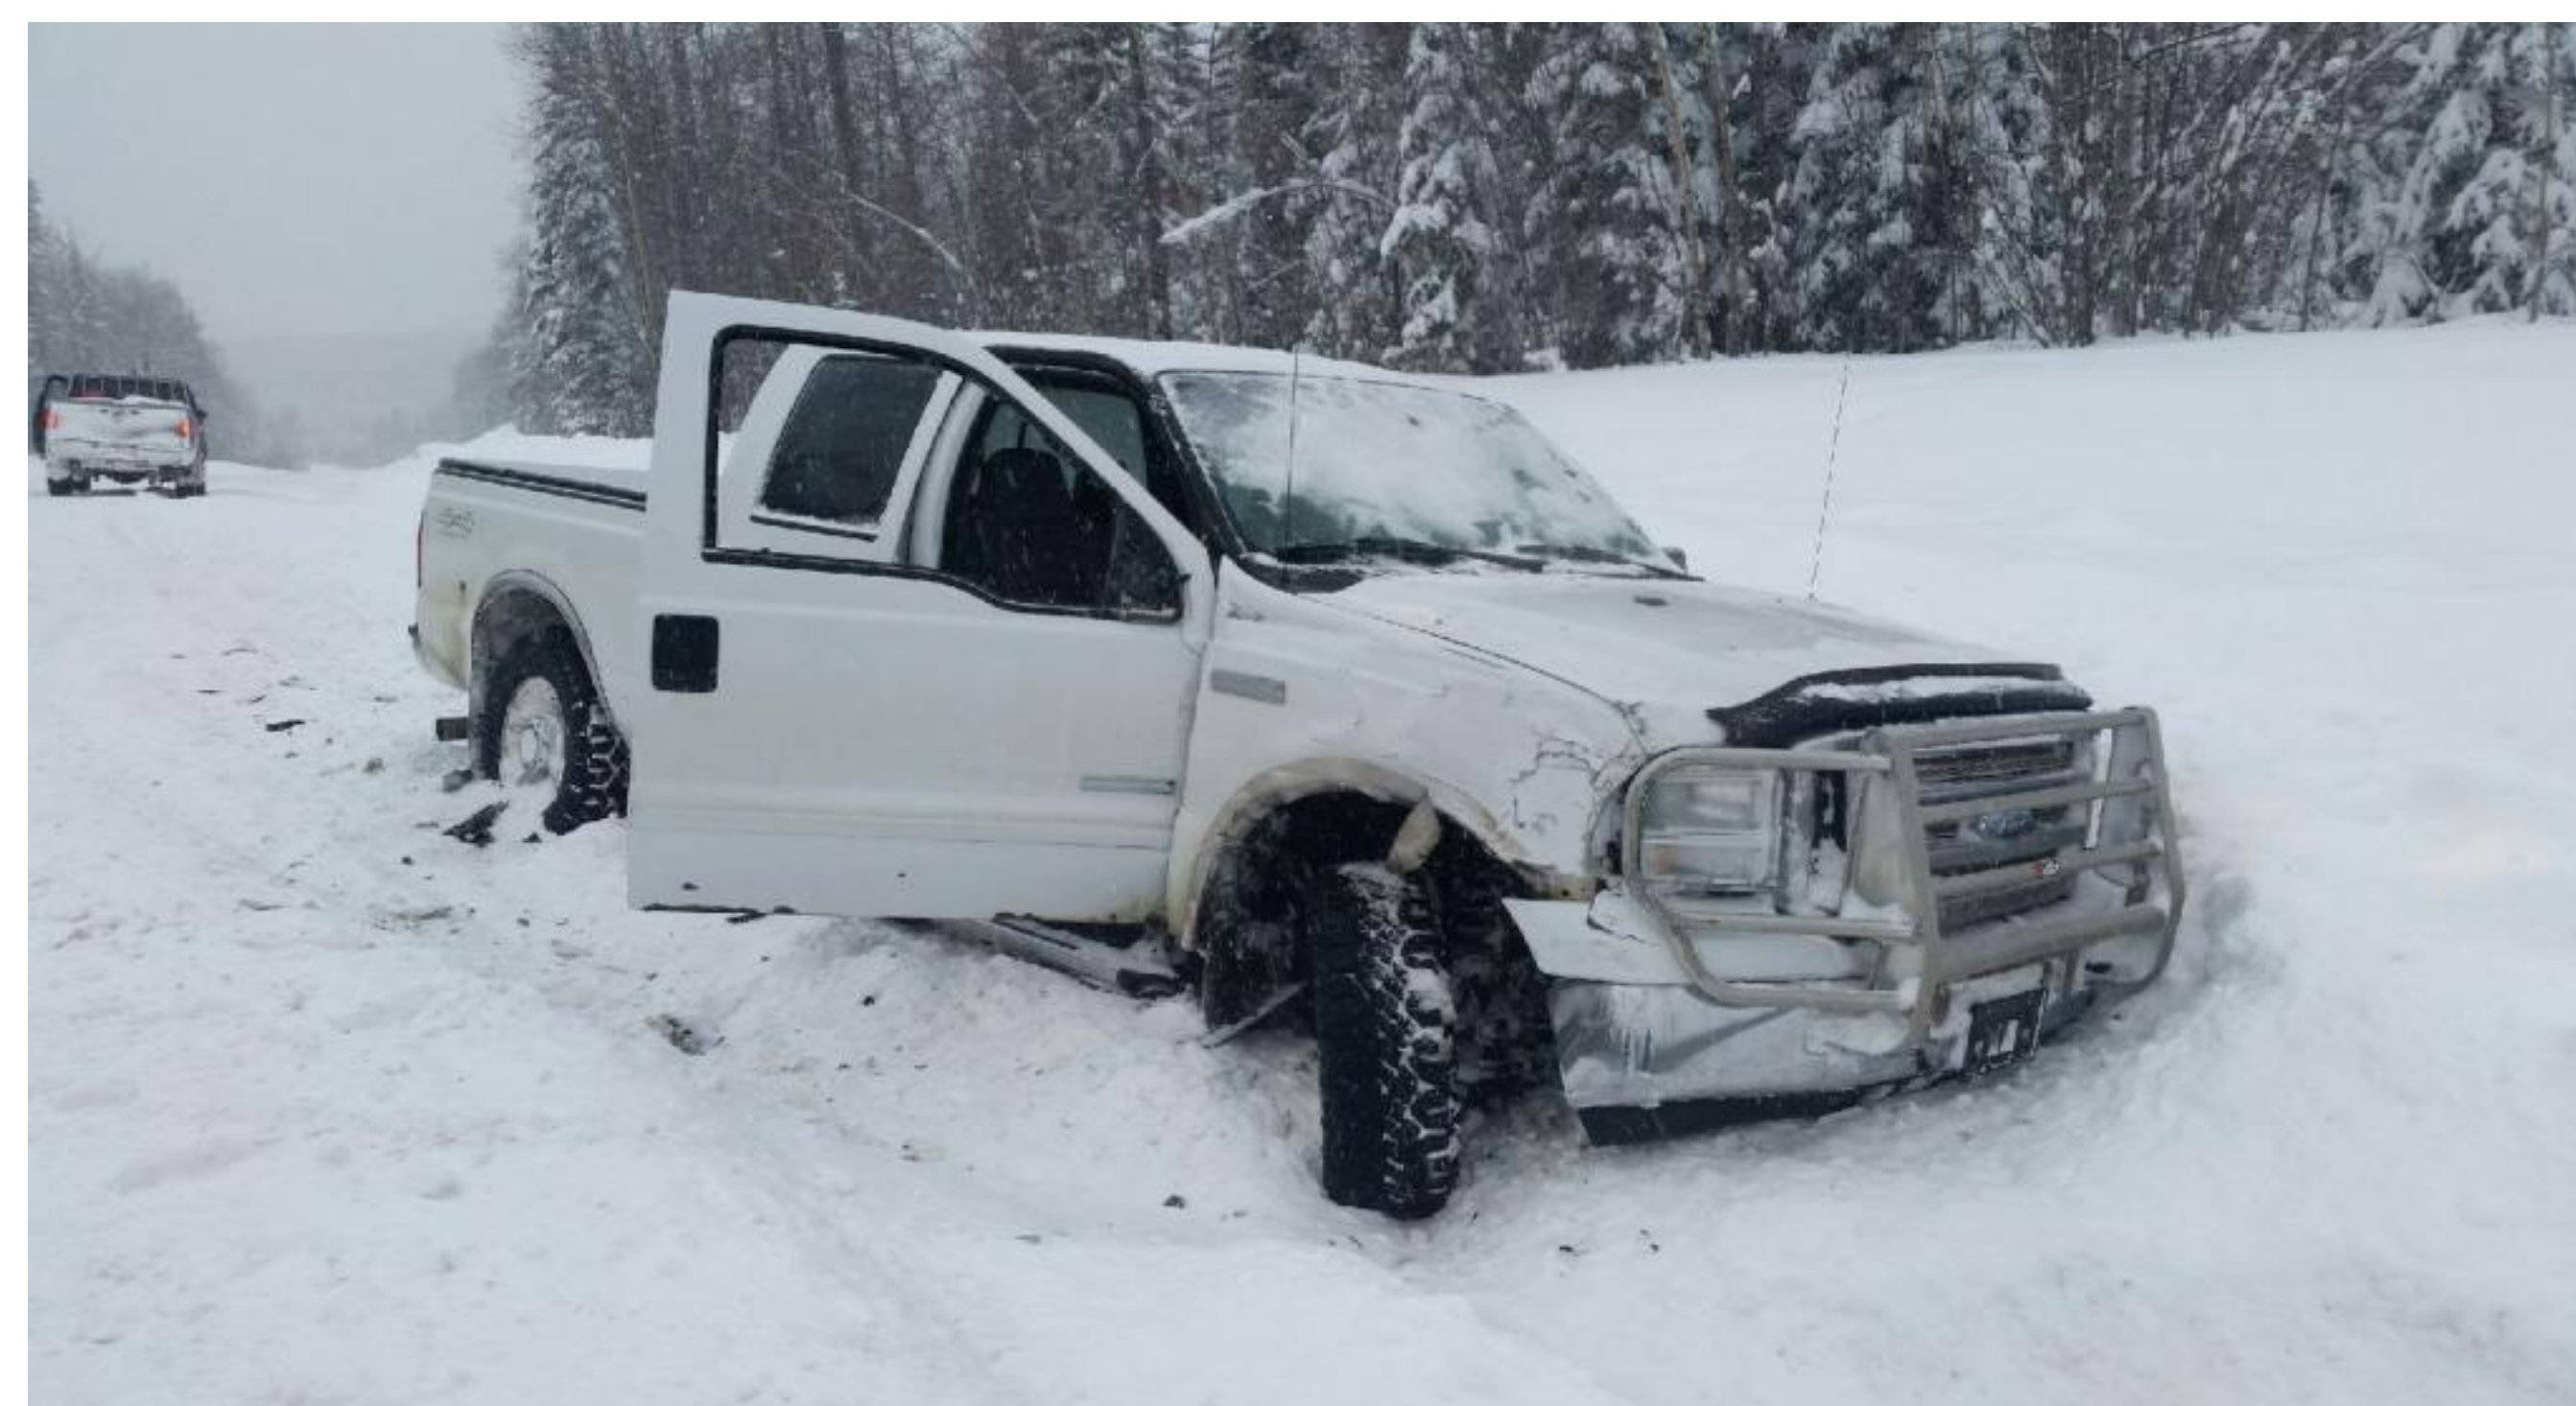
Over the weekend a seismic crew supervisor was driving in central Alberta on a resource road. The supervisor was passing a must call location at km 12 (called) at approximately 2:15pm with slick roads and low light conditions. As they came close to cresting the km 13 hill they noticed two vehicles heading towards him. A well servicing pickup truck was passing a tractor trailer in his lane. The well service operator and seismic supervisor both veered towards the same ditch opposite the tractor trailer. In a last minute attempt to avoid a head on collision the supervisor straightened out and attempted to drive between the two vehicles. This last minute decision prevented a head on collision but resulted in significant vehicle damage as the pickups contacted passenger sides.

The incident was called in over the road channel to notify other vehicles as well as the crew channel. The vehicles were positioned in an attempt to minimize the risk of traffic interference and it was verified that no medical assistance was required. Luckily no injuries were a result of the event.

- Remind all workers and contractors of the importance of complying with radio controlled resource roads
- Contact the resource road owner to report the event and its learnings
- Review defensive driving practices with all personnel and the importance of:
 - Planned trips with sufficient time permitted
 - Driving or adapt to road and weather conditions
 - Reducing speed and increasing distance
 - Having adequate rest and being fit for duty
 - Being ready for the unexpected
 - Exercising the shared responsibility of passengers

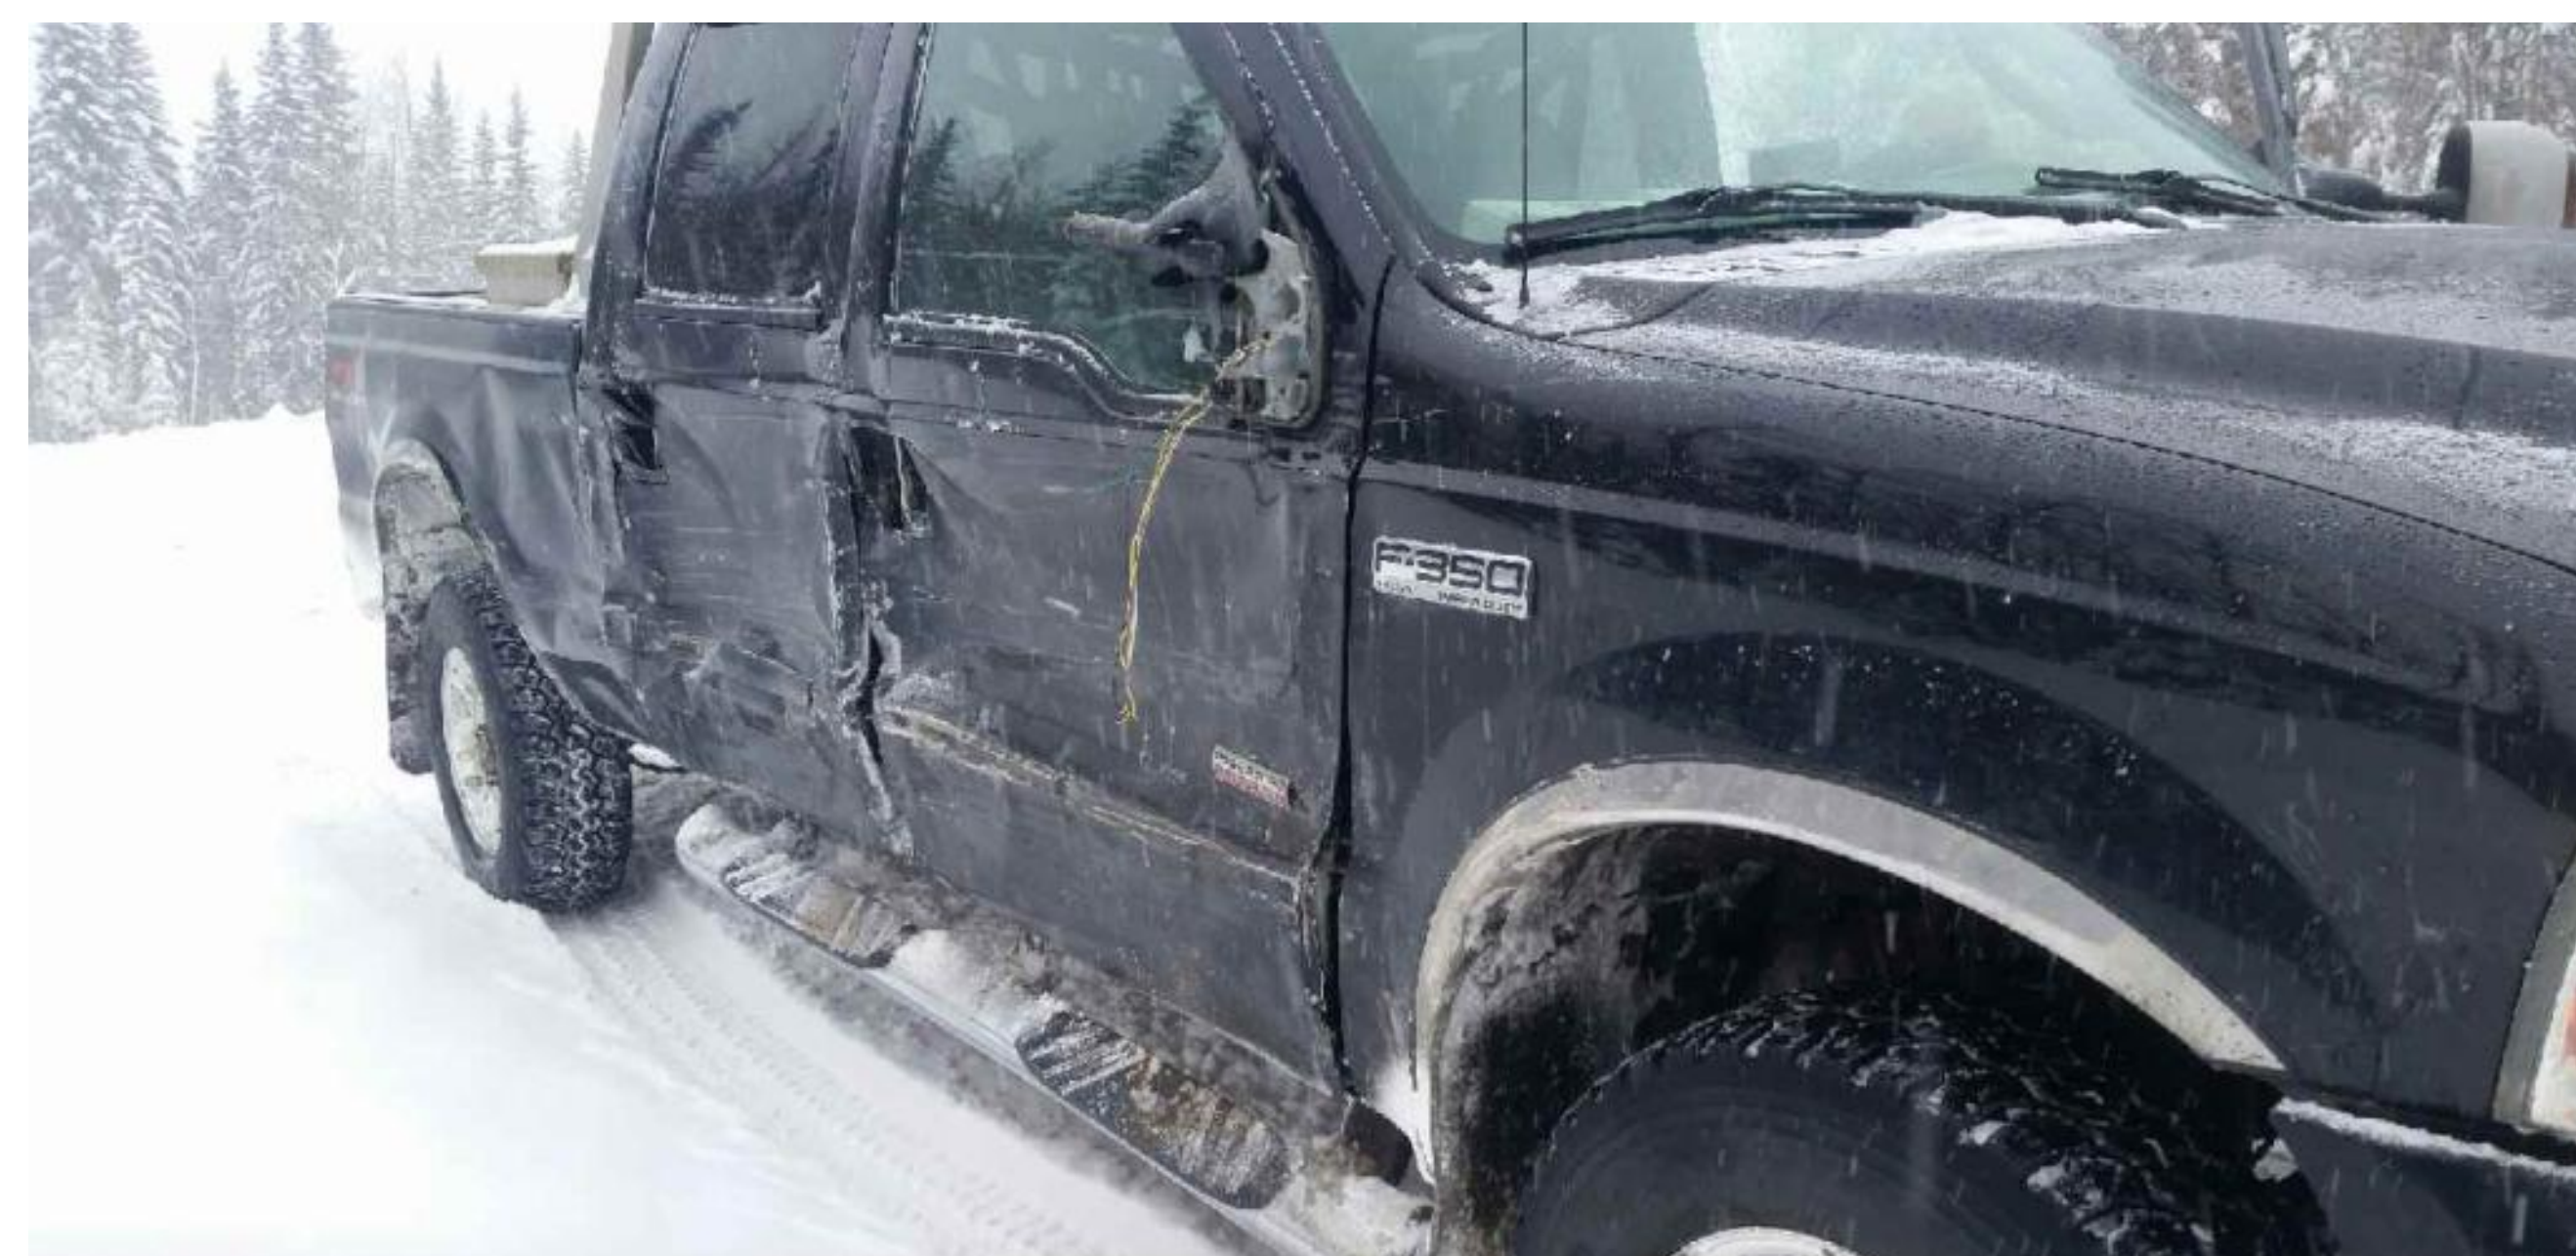
- The oncoming well servicing pickup truck failed to call in or monitor the road channel
- Poor defensive driving practices exercised by the well servicing operator to pass on a blind hill
- Failure to recognize the risk potential of recent snowfall and operate to conditions
